AN INVESTIGATION OF A THERMAL ICE-PREVENTION SYSTEM

FOR A C-46 CARGO AIRPLANE

VII - EFFECT OF THE THERMAL SYSTEM ON THE
WING-STRUCTURE STRESSES AS ESTABLISHED IN FLIGHT

ADVANCE RESTRICTED REPORT

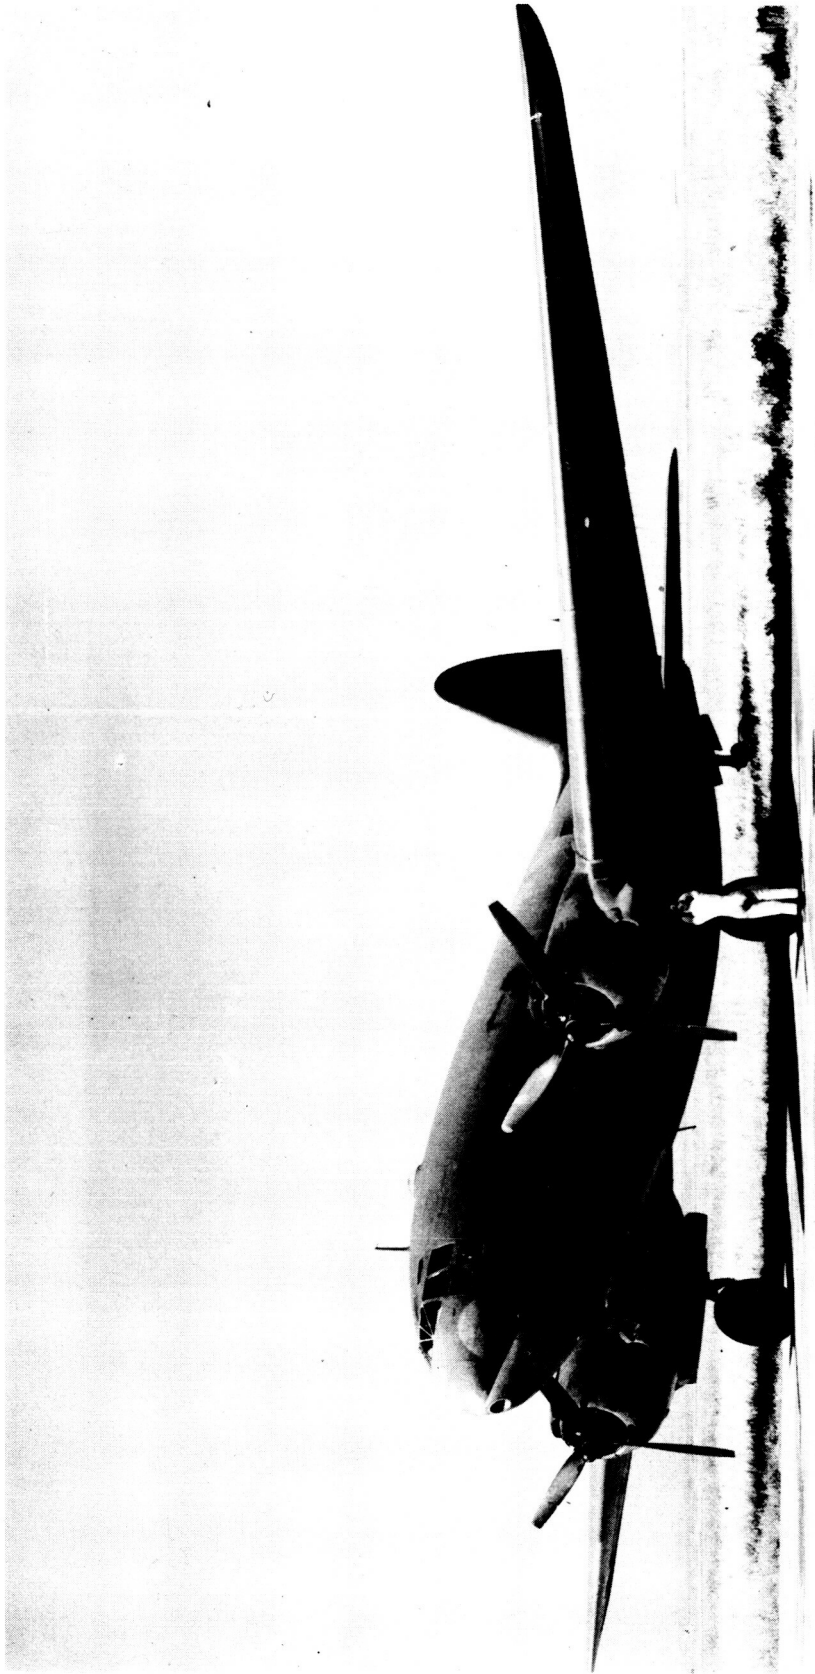
Figure 1.- The C-46 airplane equipped with a thermal ice-prevention system.

The C-46 airplane (fig. 1) is a twin-engine, low-wing, transport-cargo monoplane powered by Pratt & Whitney model R-2800-51 engines having a sea-level rating of 2000 horsepower each. The wing span is 108 feet, the wing area 1360 square feet, and the normal gross weight 45,000 pounds.

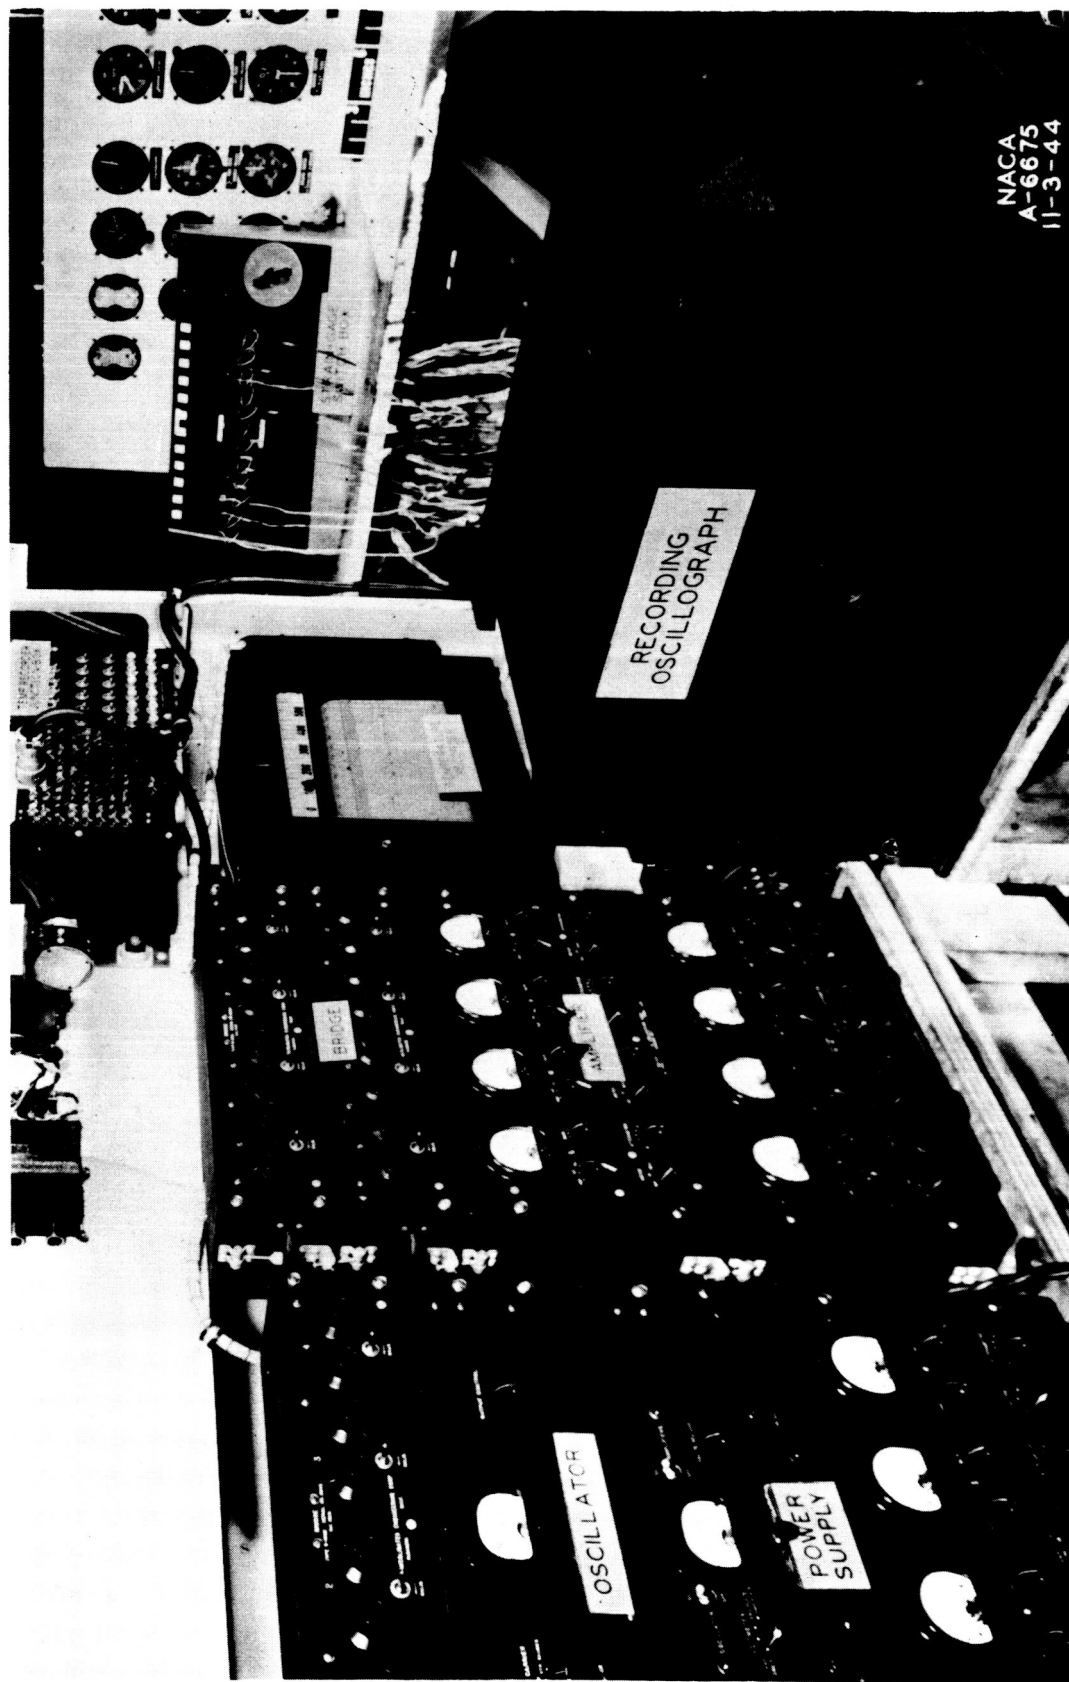
Figure 8.- Installation of instrumentation in airplane cabin for the wing thermal-stress investigation, C-46 airplane.

The strain-gage recording equipment is shown installed in the airplane in figure 8 and consisted basically of a 12-channel oscillograph, three bridges of four channels each, and three amplifiers of four channels each. The strain-gage switch box shown in figure 8 provided a means for connecting any 12 gages at one time to the recording oscillograph. A schematic diagram showing the complete circuit for one channel is presented in figure 9. The active and dummy gages were connected in two arms of a Wheatstone bridge circuit, the remaining two arms consisting of variable resistors in the four-channel

Standard NACA instruments were installed to record air-speed and normal acceleration. An NACA timer, shown installed at the left of the airspeed recorder in figure 8, was used to synchronize the airspeed, accelerometer, and oscillograph records. The accelerometer was installed on the floor of the airplane at the center of gravity and oriented to record accelerations normal to the wing chord at station 0. The airspeed recorder was connected to the service Kollsman airspeed-head installation and the error in static-pressure reading was determined in flight for all the test conditions with a trailing static pressure head.
